# RESEARCH MEMORANDUM

TESTS OF AERODYNAMICALLY HEATED MULTIWEB WING  
STRUCTURES IN A FREE JET AT MACH NUMBER 2

TWO ALUMINUM-ALLOY MODELS OF 20-INCH CHORD  
WITH 0.064- AND 0.081-INCH-THICK SKIN

By George E. Griffith, Georgene H. Miltonberger,  
and Richard Rosecrans

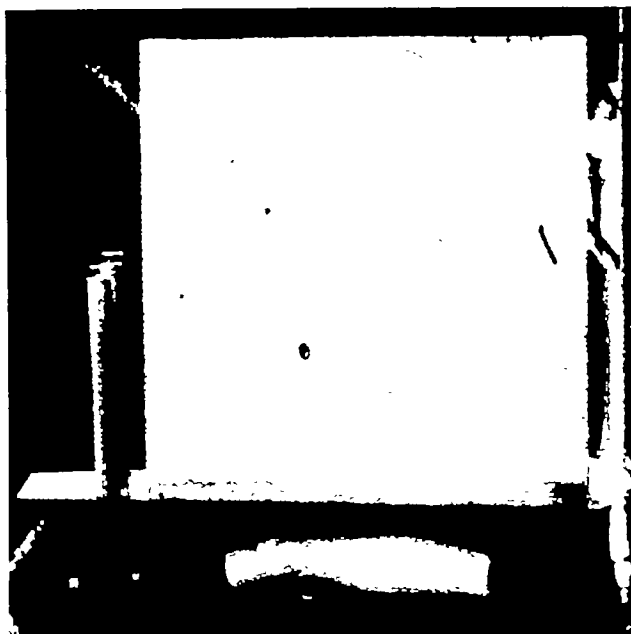
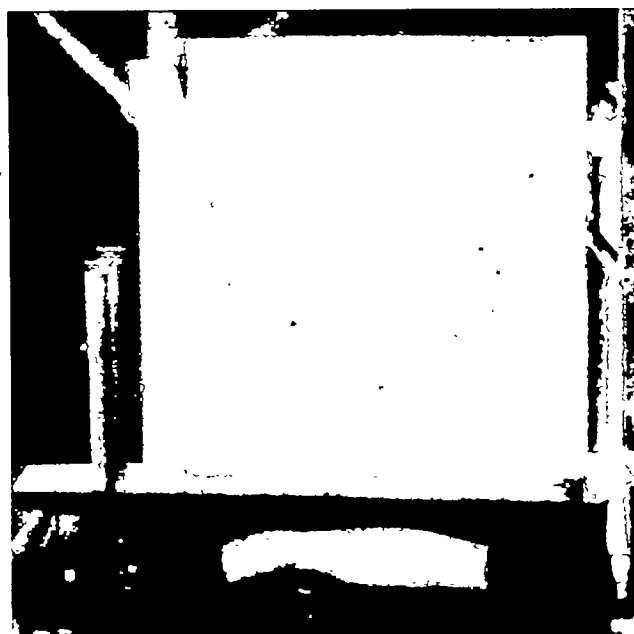
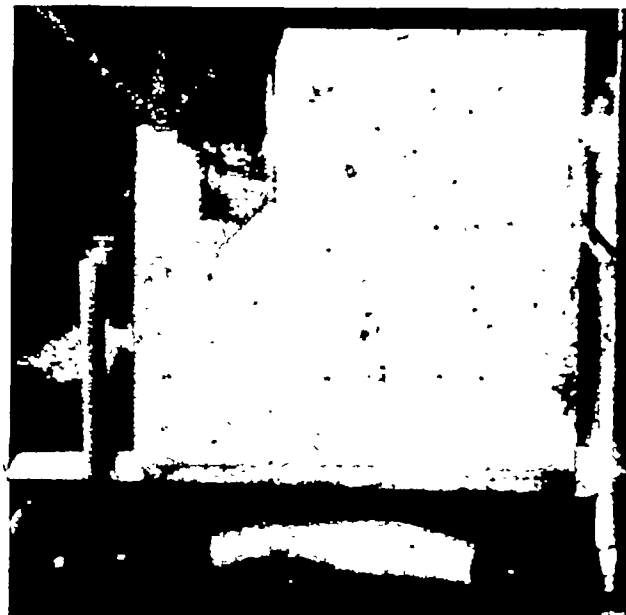
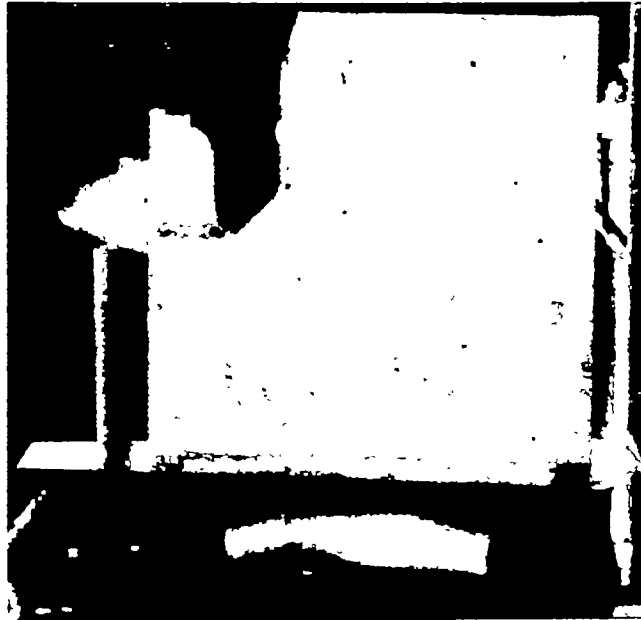
Figure 12.- Progressive failure of model MW-2.

Model MW-2.- After experiencing some random vibrations due to the characteristic initial disturbance of the jet (see the appendix), model MW-2 remained steady until 9.8 seconds. At this time, as indicated by the motion pictures taken by cameras placed above the model and by the frequency, phasing, and amplitudes of the skin strain gages across the chord 11 inches from the tip, the model began to flutter at 226 cycles per second in a mode with about  $1\frac{1}{2}$  waves along the chord and with the maximum amplitude near the trailing edge - a flag-waving action involving chordwise bending of the airfoil section that has been called chordwise flutter (refs. 2 and 8). Motion pictures taken from opposite sides of the model indicated that at approximately the same time, 10.0 seconds, a buckle had developed in the rearmost panel of both skins. At 10.8 seconds the stagnation pressure dropped below 100 lb/sq in. abs and test conditions were considered as having ended at this time. Shortly thereafter, at 11.5 seconds, and with the model still fluttering, the motion pictures showed the initial signs of failure to be a fracture of the tip rib and tearing of the adjacent skins just forward of the trailing edge. The piece of the tip rib tore away and was followed by tearing away of pieces of skin and the top part of the solid trailing-edge member. This was followed by further tearing of both skins in the next-to-last bay from the top of the model to about midsemispan, tearing away of an additional piece of skin and the trailing-edge member, and finally by the departure of the upper half of the next-to-last web. This last action occurred at 13.5 seconds by which time the entire upper rear corner had torn away. From about 13.5 to 14.2 seconds the model experienced additional disturbances associated with the shutdown characteristics of the jet. The failing action just described is illustrated in figure 12 by six frames taken from the motion pictures, and the model after the test is shown in figure 13.

The primary cause of failure was the aerodynamic heating since the model survived the starting disturbances without damage and then remained steady until the induced thermal stresses reduced the effective stiffness of the model (ref. 9) and caused it to flutter. At approximately the same time that the model began to vibrate, chordwise buckling of the skin developed in the rearmost bay; however, the exact order of flutter and skin buckling cannot be stated with certainty. The flutter could have been caused directly by thermal stresses which were insufficient to produce buckling but which were nevertheless sufficient to reduce the effective stiffness of the model to a point where flutter occurred, or the thermal stresses could have caused skin buckling (also a reduction in stiffness) which triggered off the model flutter. In either event the primary cause of failure was the aerodynamic heating. The flutter that

occurred (at 226 cycles per second) had about  $1\frac{1}{2}$  waves along the chord with the maximum amplitudes at the trailing edge, a flag-waving action involving chordwise bending of the airfoil section and referred to as chordwise flutter; the distortions were somewhat similar to those shown in figure 6 of reference 2. (This type of flutter apparently has been little observed but is discussed to some extent in ref. 8.) Shortly after the model began to flutter, a fatigue failure of the tip bulkhead occurred in the form of tearing across the bulkhead at a section weakened by rivet holes. The adjacent skins (both sides) began to tear and the destruction continued as previously described. Since test conditions ended at 10.8 seconds and the bulkhead failure occurred at 11.5 seconds, all visible destruction actually took place during a period of decreasing stagnation pressure; had the jet continued to run, the model undoubtedly would have been completely destroyed. Motion pictures of the tests of models MW-2 and MW-3 can be obtained on loan from NACA Headquarters, Washington, D. C. (film entitled "Supersonic Jet Tests of Simplified Wing Structures").

Although the preliminary results of reference 2 indicated that the flutter of model MW-2 was induced by thermal buckling of the skin, the more extensive study of the motion pictures and the strain-gage records reported herein reveals that it is impossible to state positively the order in which these events occurred. The skin buckle in the rearmost bays (each side) developed gradually (and may also have been developing to a lesser extent in other bays), so that it is impossible to assign an exact time of buckling; hence, the time given (10.0 seconds) is that when an obvious buckle had developed. The wire strain-gage records reveal more definitely that at 9.8 seconds, approximately the time of skin buckling, the model began to flutter as already described.

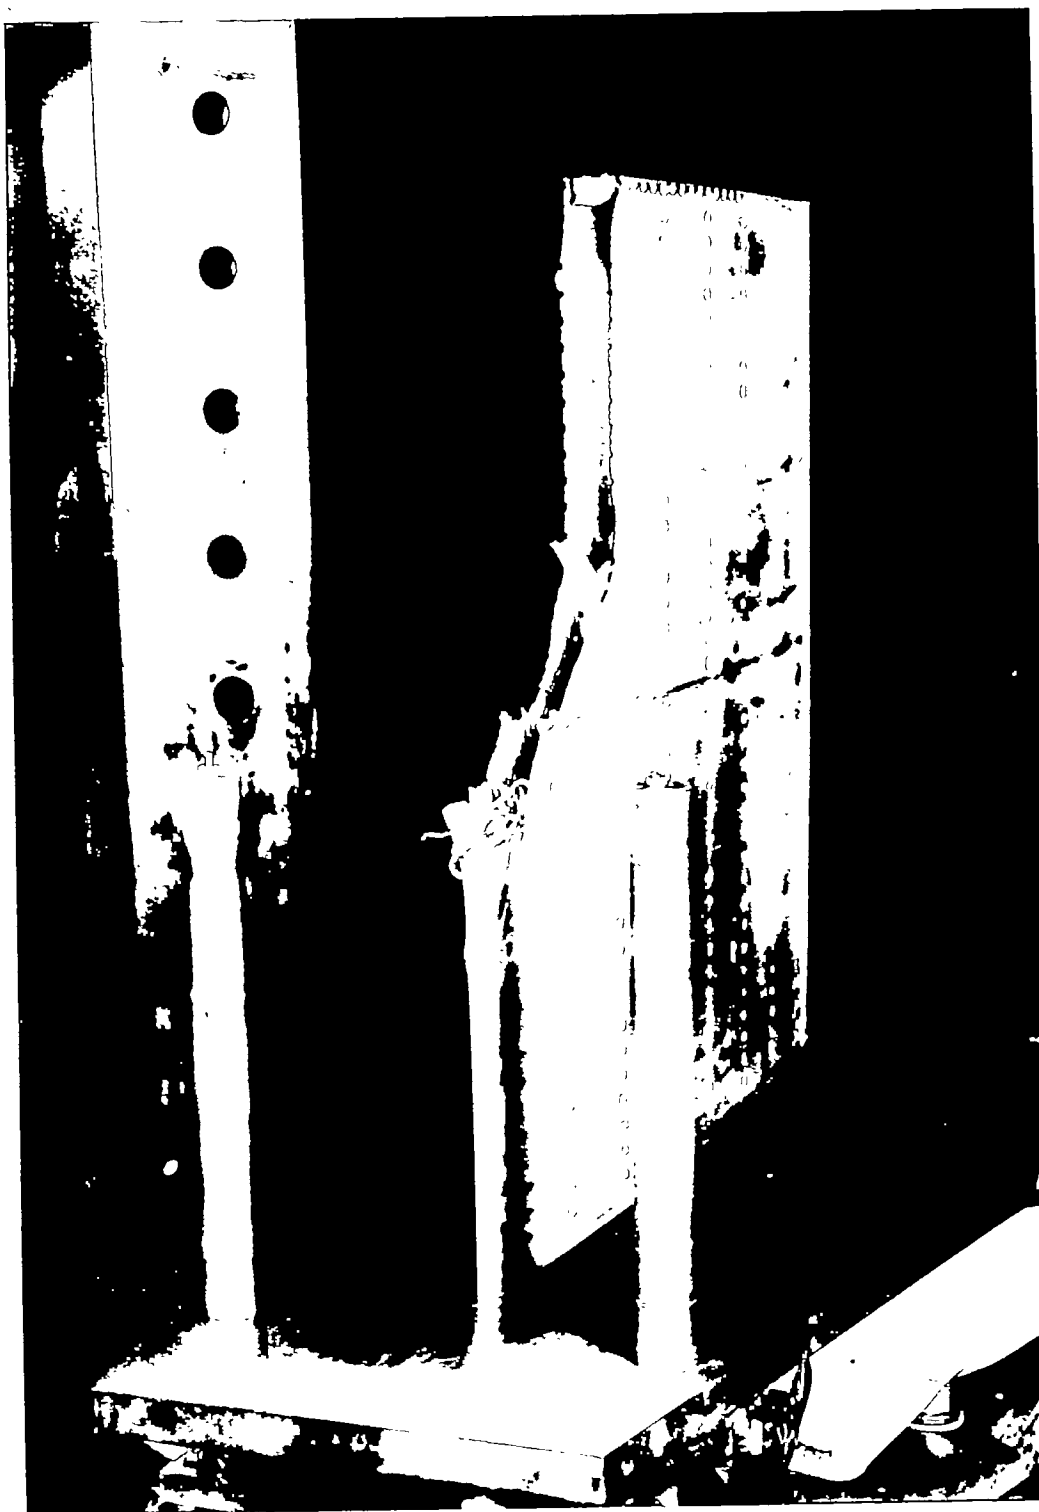
I-77204

Figure 13.- Model MW-2 after test.

The failures of model MW-2 and its larger scale original model MW-1 were fundamentally similar in that flutter, either accompanied by or closely preceded or followed by skin buckling, resulted in failure in the vicinity of the trailing edge. The primary cause of failure in both tests was aerodynamic heating. The thinner skin of model MW-2 caused its skin to become hotter faster than the skin of model MW-1, and the hotter skin and smaller webs of model MW-2 also resulted in higher interior

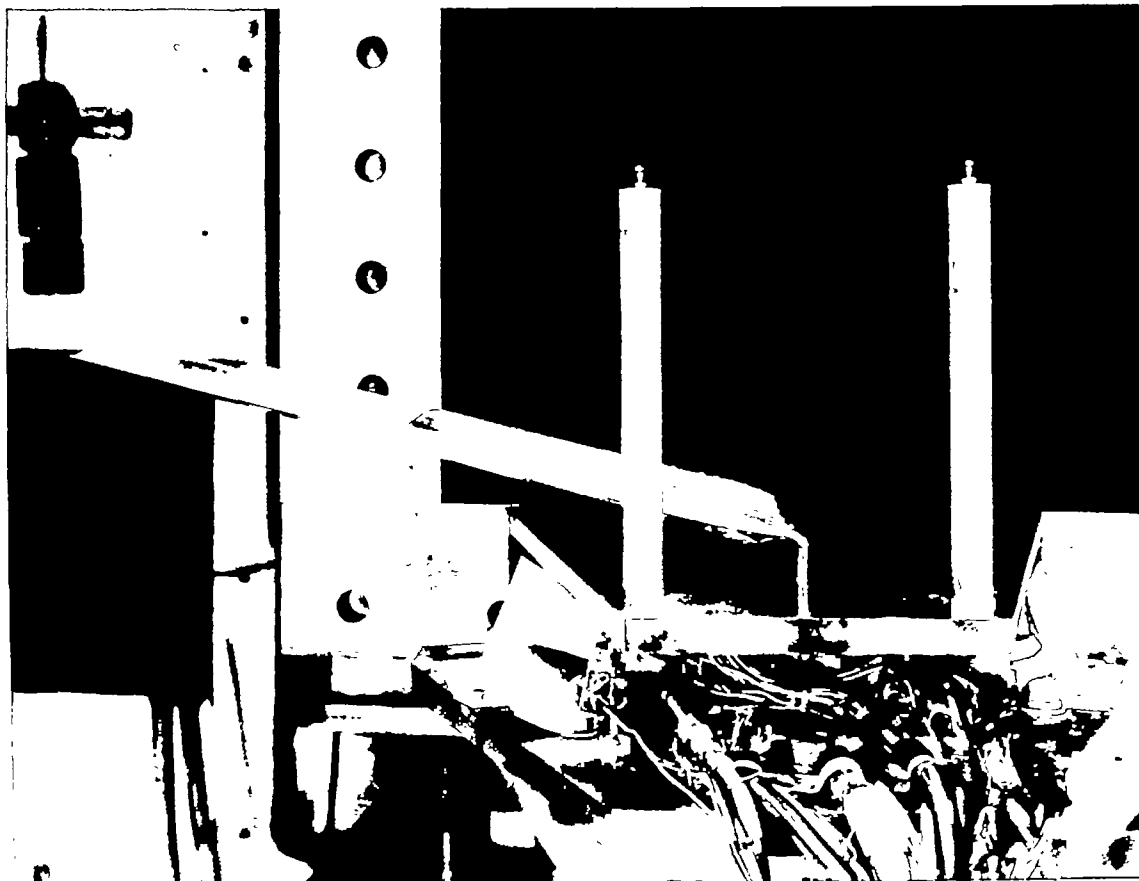
Figure 14.- Model MW-3 after failure. L-77699

Model MW-3.-- Beginning at 0.2 second after the air began to flow through the jet, model MW-3 (at an angle of attack of  $5^\circ$ ) vibrated, mainly in bending, at approximately 65 cycles per second until the initial normal shock reached the leading edge of the model. At this time, 1.0 second, the model steadied. The normal shock wave had moved to the model midchord at 1.2 seconds, then moved downstream and disappeared. The model continued to remain steady until 1.8 seconds, at which time test conditions had been reached and the aerodynamic forces had become sufficiently large to produce compressive buckling of the skin at the root section. At this time the model collapsed on its side to the position shown in figure 14.

The failure was almost entirely independent of any aerodynamic-heating effects, since the maximum measured temperature rise ( $70^\circ$  F) was insufficient to produce any noticeable changes in the properties of the material and the temperature differences in the structure (approximately  $35^\circ$  F near the middle of the model) were so small that only negligible thermal stresses had developed. Thus the failure was almost solely due to aerodynamic loading. At the time of failure the aerodynamic forces had increased to slightly beyond the prescribed value ( $H = 106$  lb/sq in. abs), and the calculated force of about 6.7 lb/sq in. (970 lb/sq ft) was sufficient to cause the skin to wrinkle completely across the chord and to crush the webs on the compression side of the model. As soon as the skin wrinkled the aerodynamic forces pushed the model completely over on its side.
